INVESTIGATION OF THE STRESS CORROSION CRACKING  
SUSCEPTIBILITY OF ANNEALED AND HEAT TREATED  
ALLOY 625 CASTINGS AND FORGINGS IN SEA WATER

NAVAL ENGINEER  
and  
MASTER OF SCIENCE IN MATERIALS ENGINEERING

at the  
MASSACHUSETTS INSTITUTE OF TECHNOLOGY  
June, 1987

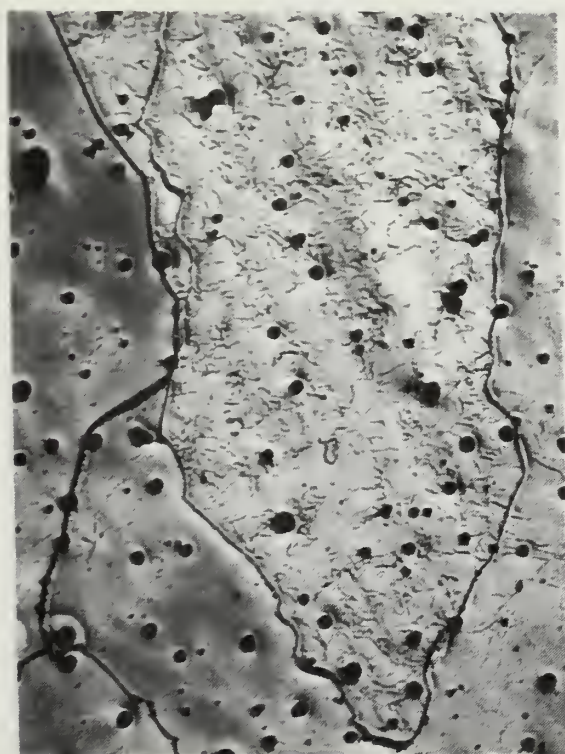
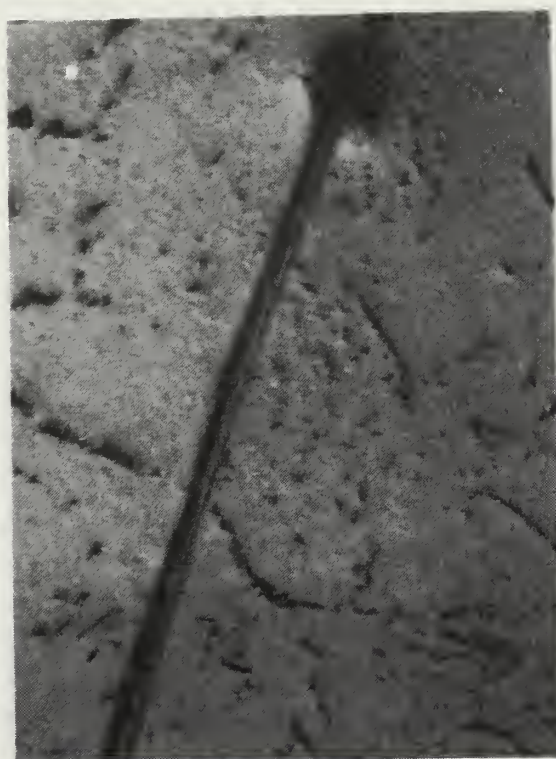
**Figure 7** Photomicrographs of "Cast/Heat Treated" Alloy 625

Heat treating the cast material in Figure 7 caused what appears to be globular or blocky  $M_{23}C_6$  carbides on the grain boundaries. The bottom photomicrographs show dislocation slip bands throughout the matrix and heavy growth along the grain boundaries.
